MASSACHUSETTS COASTAL BASIN KINGSTON, MASSACHUSETTS

RUSSELL POND DAM MA 00392

PHASE I INSPECTION REPORT
NATIONAL DAM INSPECTION PROGRAM

**MAY 1979**

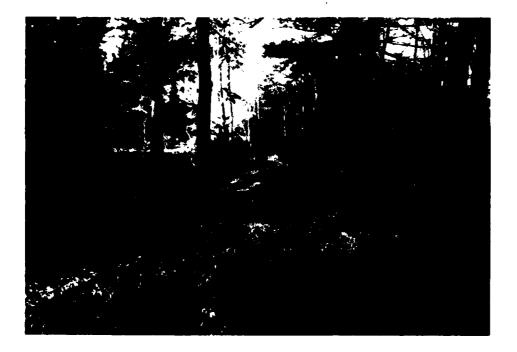
3. Dam crest from east abutment.

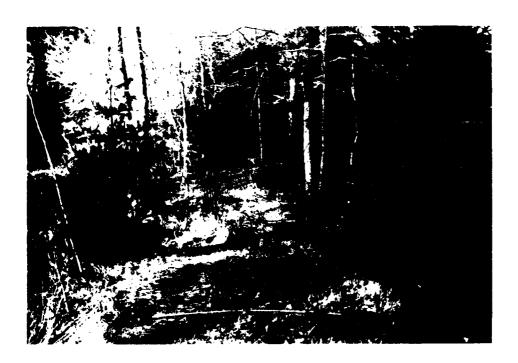
4. Eroded section in middle of dam crest, looking from east to west.

- (1) Provide riprap or cobble slope protection on the upstream face of the dam. Restore and re-shape local eroded areas.
  - (2) Re-shape the dam crest to provide uniform freeboard and to facilitate access for maintenance and repair. The extent of the re-shaping will be subject to the results of the evaluation of actual embankment configuration under Section 7.2
